Agenda Item: CEP 8b
Presented by: Korea (ROK)
Original: English
Submitted: 17/04/2013

Mitigation measures of environmental impacts caused by Jang Bogo construction during 2012/13 season

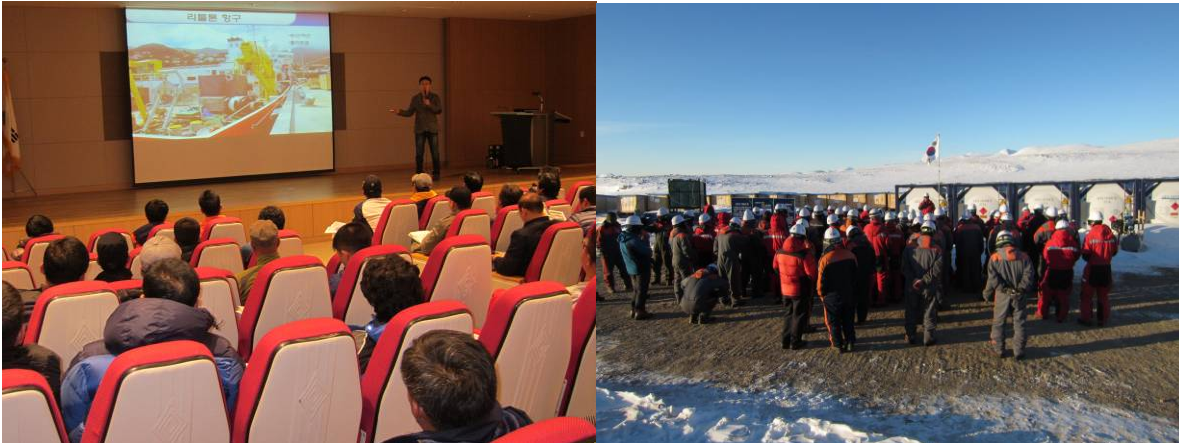
Before departure, all construction members participated in environmental education programmed by KOPRI. The education includes introduction of natural environment in Terra Nova Bay, measures for the reduction in risk of transfer of non-native species and oil spill prevention and contingency plan.

Figure 1: Environmental education for all construction members in Korea and exercise at the site for contingency

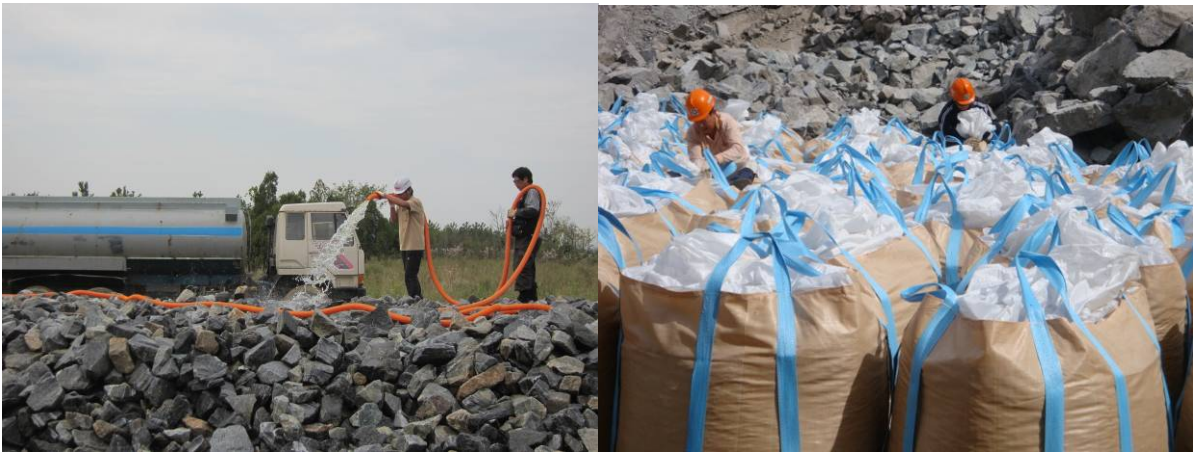
Figure 2: Cleaning and packing the riprap for pier foundation

Non-native species (NNS) may be introduced through construction equipment or other materials associated with personnel imports to the Antarctic. Non-native soil imports may also transfer NNS such as seeds and propagule. In order to prevent the introduction of NNS possibly transferred by personnel, equipment or supplies, NNS Manual annexed to the Resolution 6-ATCM XXXIV was followed. Items such as riprap for foundation and the tracks and wheels of vehicles cleaned before loading. All packing materials such as timber, and containers were thoroughly sanitized and fumigated before using.

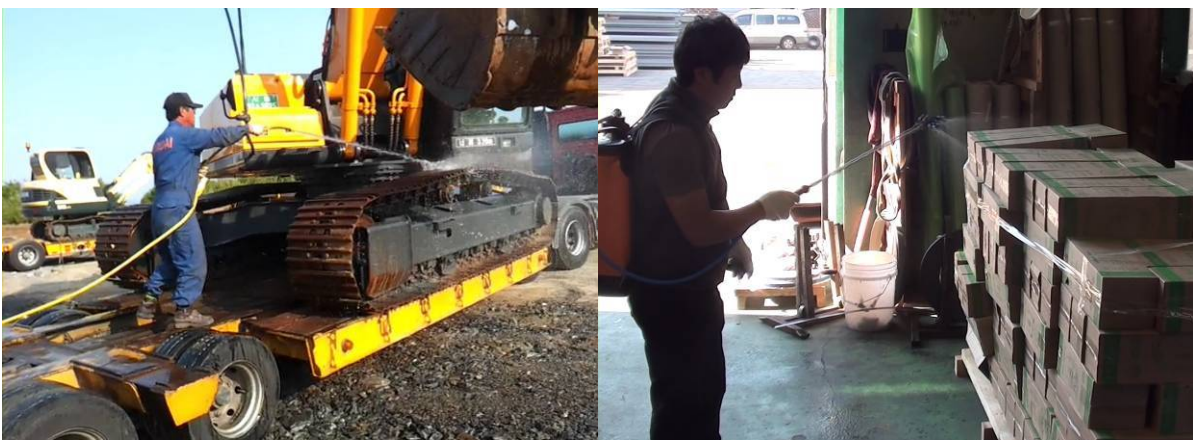
Figure 3: Cleaning a tracked vehicle and sanitizing supplies before packing and shipping.

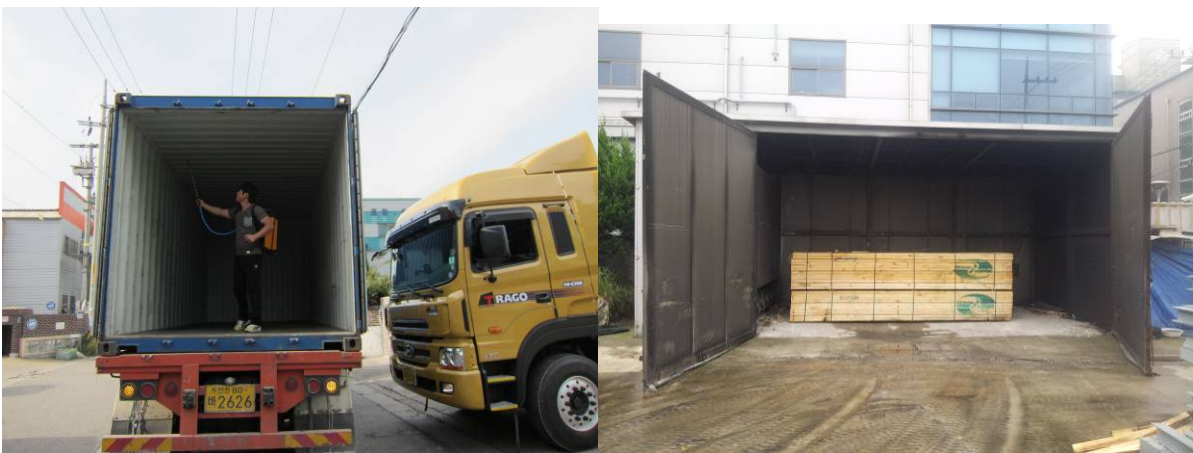
Figure 4: Sanitizing container and fumigating timber before packing of supplies

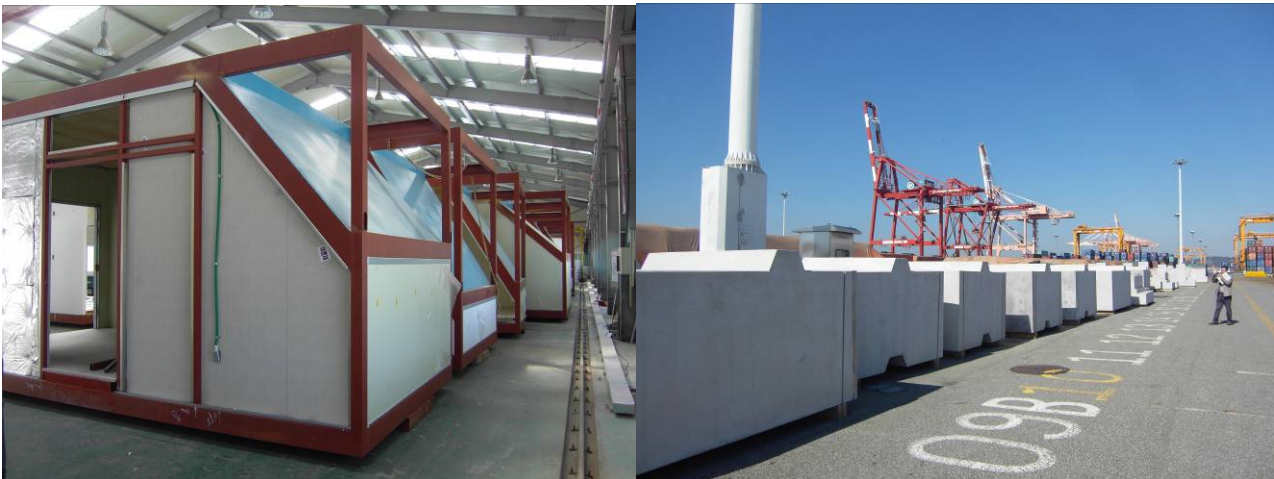
Figure 5: Modules for the main building and precast concrete foundations waiting for shipment

The modular construction helps to reduce substantial quantities of construction waste. In order to further reduce waste in the Antarctic, packing materials were removed from the supplies before loading as far as possible.

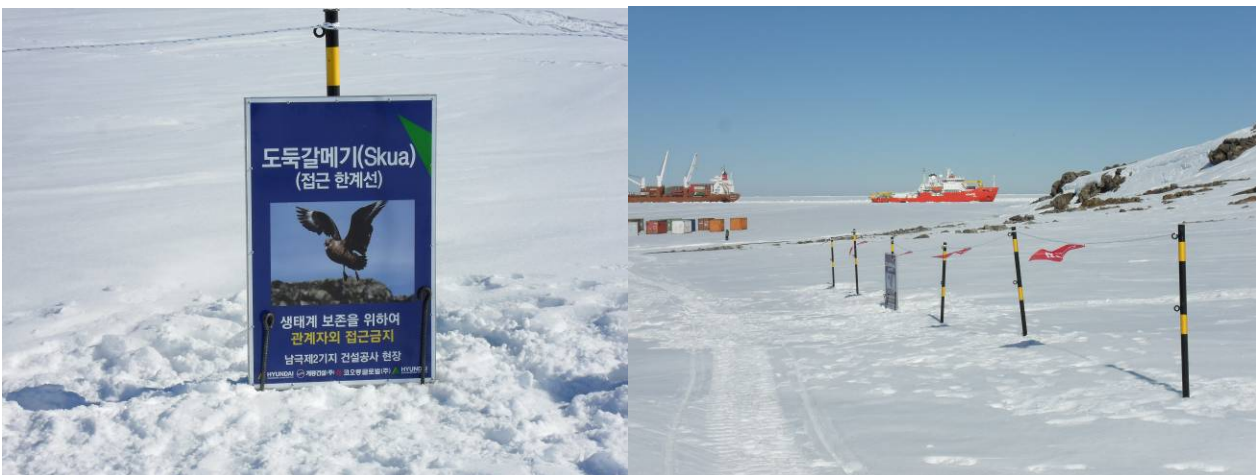
The colony of south polar skua located in the eastern hill of the Gondwana Station was not directly disturbed due to the construction activity. To avoid disturbance to the colony, unnecessary visiting by either construction workers or other personnel was strictly controlled and restricted. Low altitude flying of helicopters over the colony was also strictly prohibited. Two ornithologists monitored the colony for some period to observe impact.

Figure 6: A signpost and barrier notifying restricted area to conserve south polar skua colony

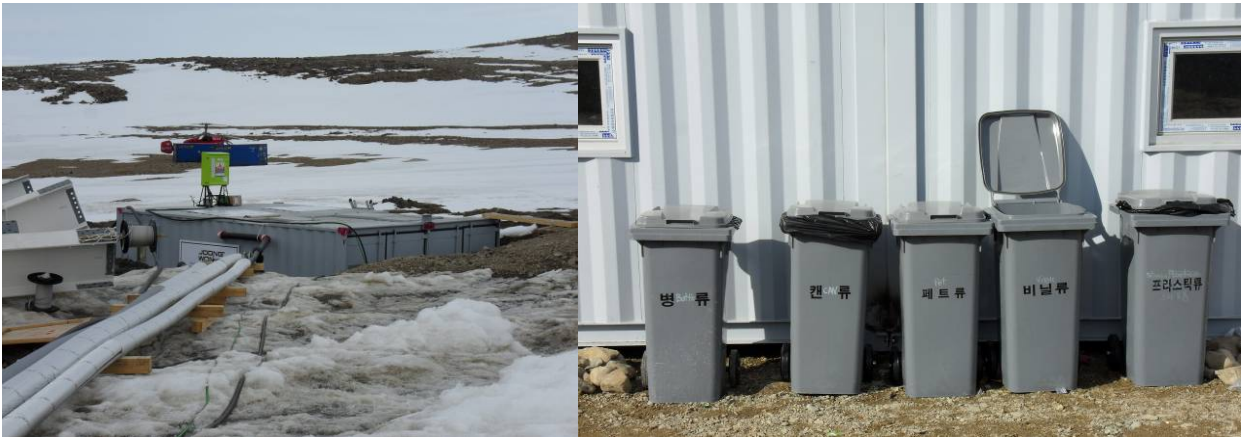
Figure 7: IC-SBR waste water treatment system and waste separation bins

Waste produced during the construction period was managed according to 'Jang Bogo Station Waste Management Manual'. Construction and domestic wastes were collected separately for recycling and reuse if possible. Waste storage was carefully cared in order to prevent wind dispersal and scavenging by skua. Ten 20ft and three 40ft containers with wastes including reusable materials and five 20 ton liquid tanks filled with oil contaminated water were removed from the site by the cargo ship. IC-SBR system was installed and operated for wastewater treatment during the construction period.

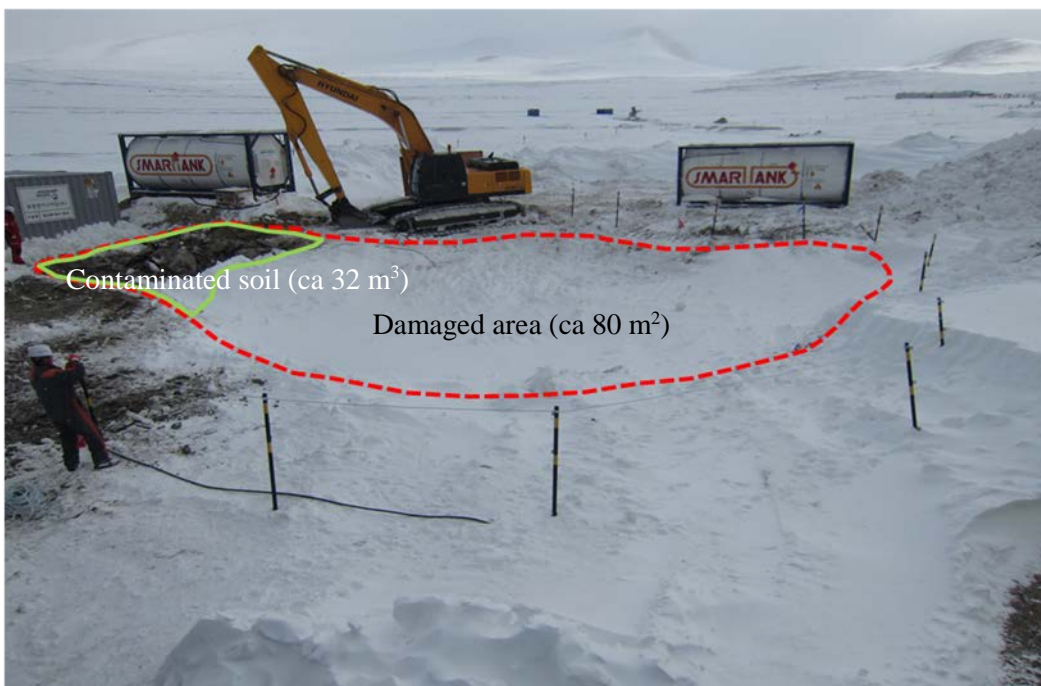
Figure 9: Damaged area with fence and about 32 m³ of contaminated soil was removed.

The fuel supply tank installed at the construction camp was connected to a supply hose with two valves. A generator engineer turned off the only second valve and forgot turning off the first valve after refuelling a service tank for generator. Then he left the hose hanging on the service tank and the hose dropped down due to the strong wind. Dropping hose hit the second valve which leads to fuel spill about 1,100 l on 20 February 2013. Spilled fuel flowed over inclined snow ground then flowed a few meters into an artificial pond.

Immediately after detecting fuel spill, all necessary measure was taken properly according to 'Jang Bogo Station Fuel Spill Contingency Plan'. 200 l of fuel was recovered and absorbing mats and five 20 ton tank filled with contaminated water were taken out from the site. About 60 tons of contaminated soil and snow kept in 20ft containers were left at the site. The containers will be transferred to Korea after the second phase of construction in 2014.

The valve of fuel supplying hose will be changed with a rotary valve which is secure from outside shock. The training course related with oil spill prevention and emergency response will be strengthened. The damaged area will be monitored by KOPRI's environmental monitoring team every year. The oil spill report was uploaded on AINMR at COMNAP website according to Annex of Resolution 6 (ATCM XXII).
