**Information on the Progress of the  
Renovation of the King Sejong Korean  
Antarctic Station on King George Island,  
South Shetland Islands**

Background Paper submitted by the Republic of Korea

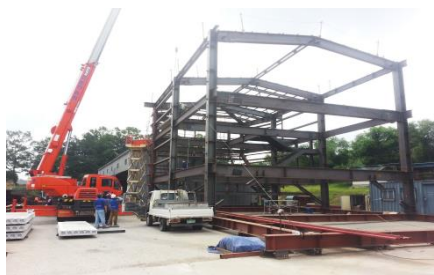
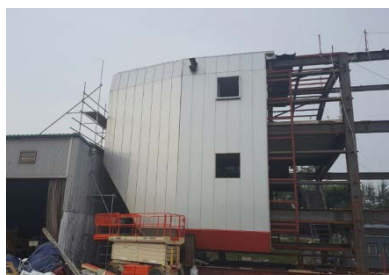
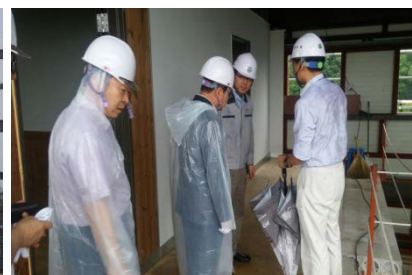
Figure 1. Pre-assembling the summer accommodation building of the King Sejong Station in Korea.

The new summer accommodation building of the King Sejong Station was pre-assembled in Korea in order to obtain effectiveness in construction and reduce waste in the Antarctic. Every step of the assembly was tested in Korea from May to July 2016.

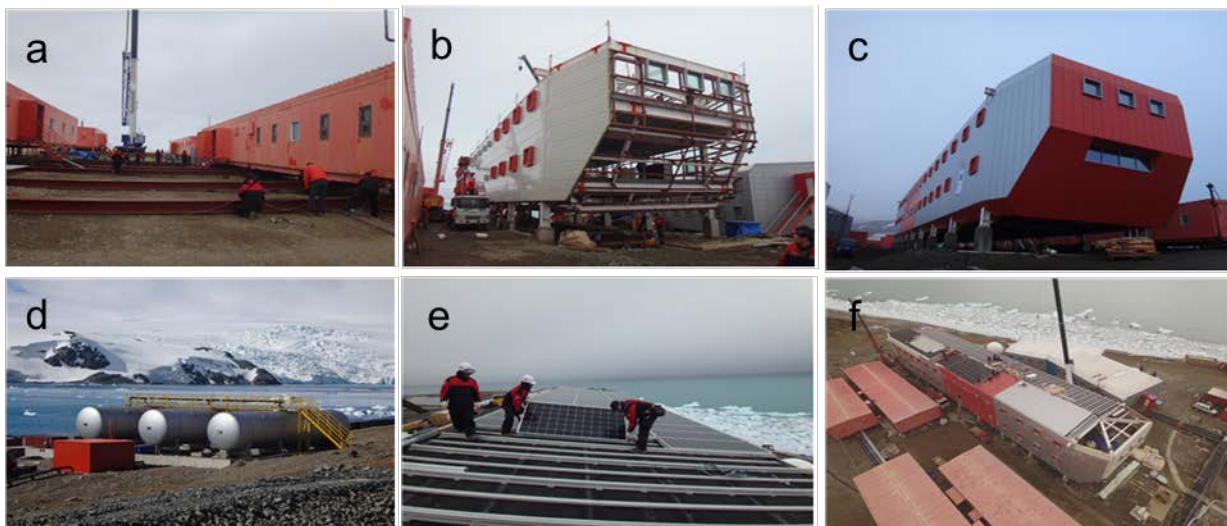
Figure 2. Construction activities in King Sejong Station. (a) Shifting the old buildings to reuse it as temporary modules. (b), (c). Two-story summer accommodation building. (d) Newly replaced double skinned fuel tanks. (e), (f). Installing solar panels on the roof.

Temporary camp for construction crews was set up by reusing old buildings such as former laboratory and emergency modules which was scheduled to be demolished by the end of 2016/17 season. The removal of the old facilities and replacement of fuel tanks were completed. Solar panels (51.2 kW in total capacity) were installed on the roof of the new two-story building for research and summer accommodation. The building has been almost completed except parts of electrical and interior works. The overall construction process will be about 86% completed when the construction personal will be evacuated.

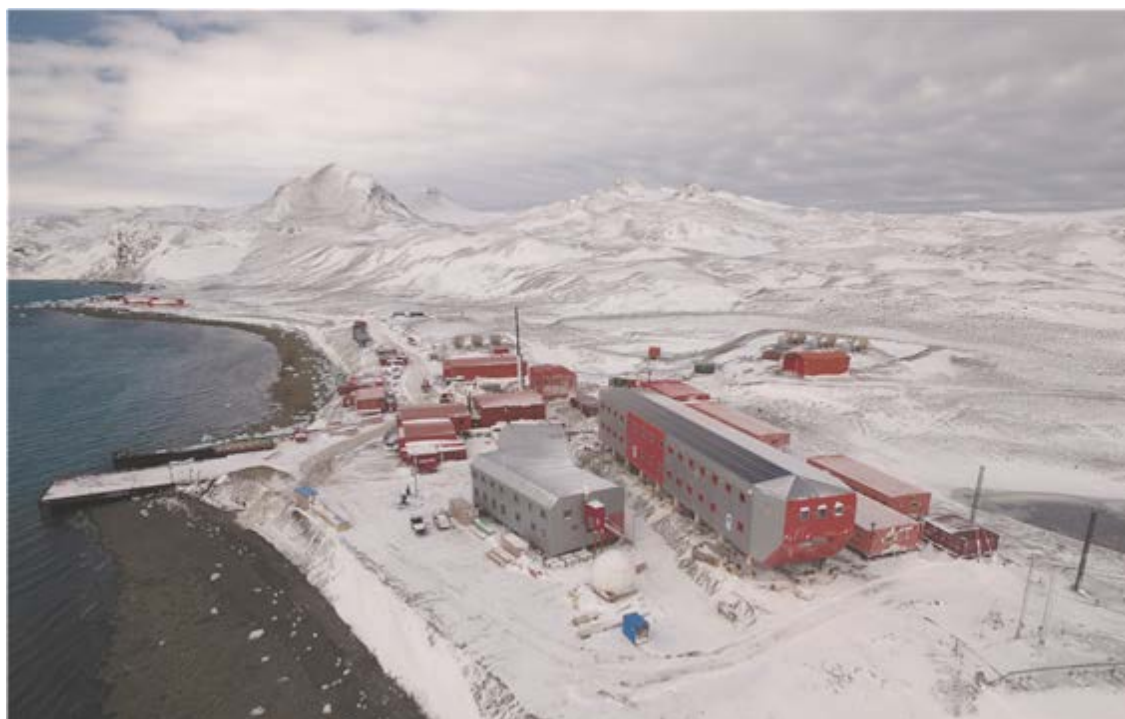
*Figure 3. Aerial view of the King Sejong Station during the first renovation phase (on 1 March, 2017).*
